**RWANDA NATURAL RESOURCES AUTHORITY  
INTEGRATED WATER RESOURCES MANAGEMENT DEPARTMENT**

## **UPPER NYABARONGO CATCHMENT REHABILITATION PLAN**

Kigali, January 2017

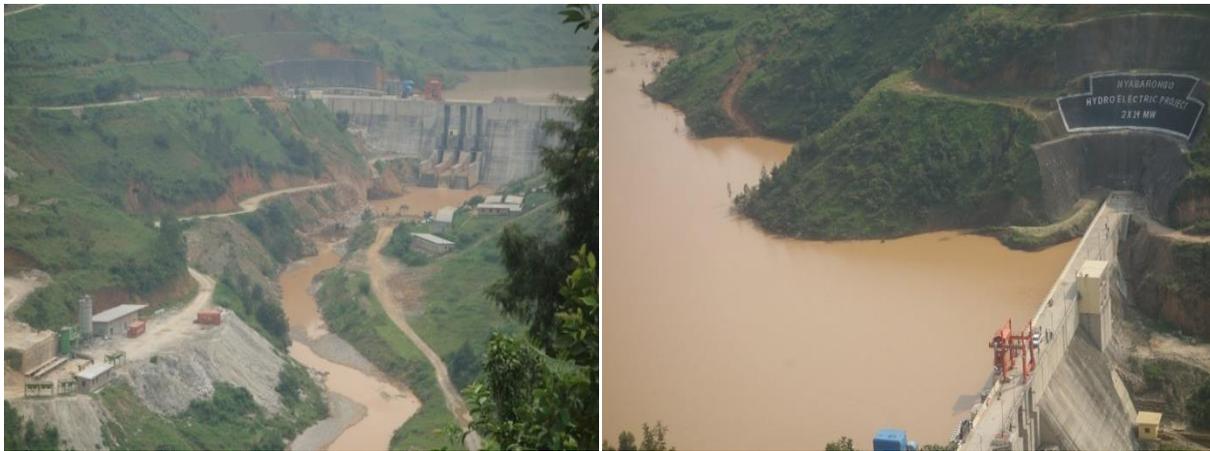
Figure 1: Nyabarongo 1 hydropower plant dam

A hydropower dam on the Nyabarongo River is located downstream at the project area outlet in the sector of Mushiro, the district of Muhanga. The dam reservoir is located in a mountainous area with steep slopes around it. Figure 2 provides a general overview of the reservoir location surrounding environment.

In situ observation indicated rolling stones from high altitudes, gravel and soil in the reservoir. All these debris endanger the turbines as well as the reservoir itself through loss of storage volume and the catchment through heavy soil losses. An activity map of the project area is provided in Figure 3, where the major stakeholders' activities especially the private sectors are located.

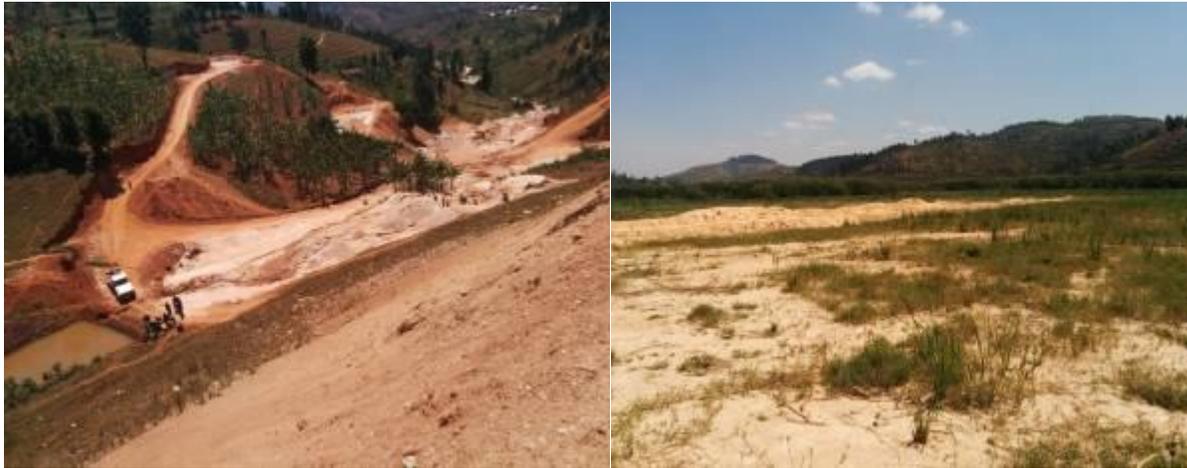
**Figure 3: Mining Site on the left draining sediment downstream in the Mwogo wetland**

Heavy land degradation and erosion due to mining activities was observed in Rurangazi cell, Nyagisozi sector, in the Nyanza district. The Mwogo river wetland is under heavy pollution as a result of the mining activity using the stream Nyanza for cleaning minerals. Havilla mining company had the site before then Mawaid Company took it, although measures are being put in place there is still alarming degradation that need to be fixed urgently. An illustration is provided on Figure 4.

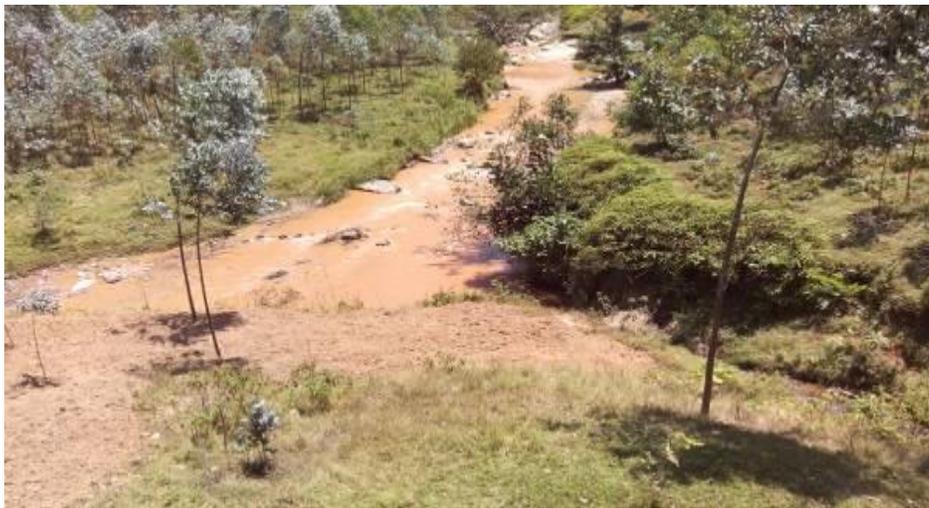
**Figure 4: Mbirurume River under heavy siltation**

It was also observed that the Mbirurume River has a high sediment load due to mining activities in its upstream by the mining company named KOKAMIKE. Figure 5 illustrates the current aspects of the Mbirurume River in the Gasharu cell, Mutuntu sector in the Karongi District.

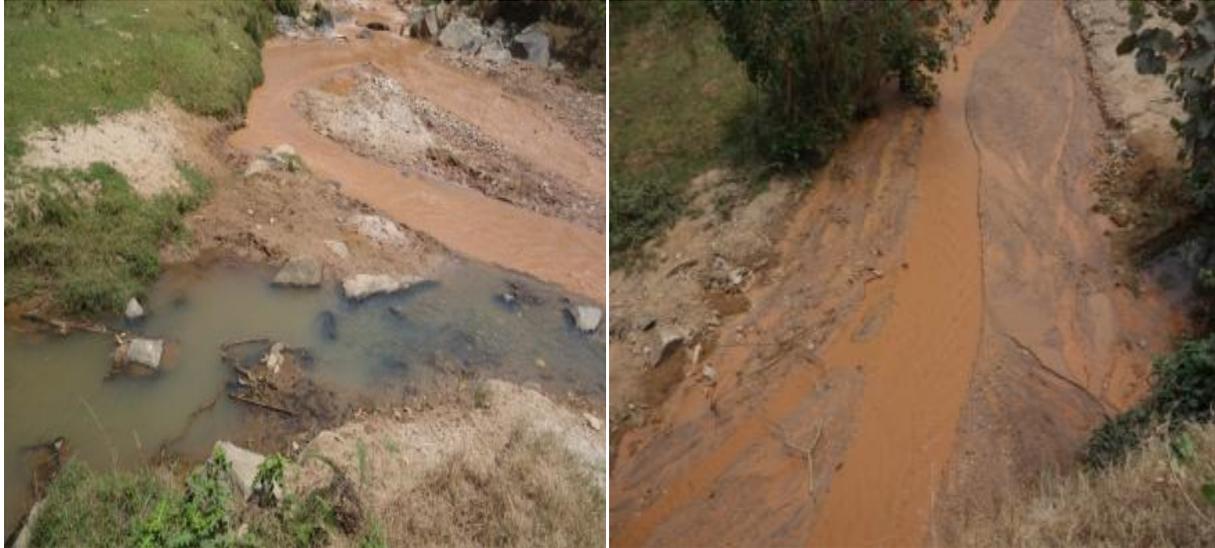
**Figure 5: Secoko and Rubanda streams current aspects**

Observation made indicated the current pollution and potential for pollution of the dam from irresponsible mining activities in its vicinity. The biggest sediment contributors were identified as Secoko and Rubanda streams flowing from the former Gatumba Mining concession. A group of mining companies operate in this concession in an illicit manner. High sediment load from this streams is directly discharged in the reservoir as it is illustrated on figure 6.

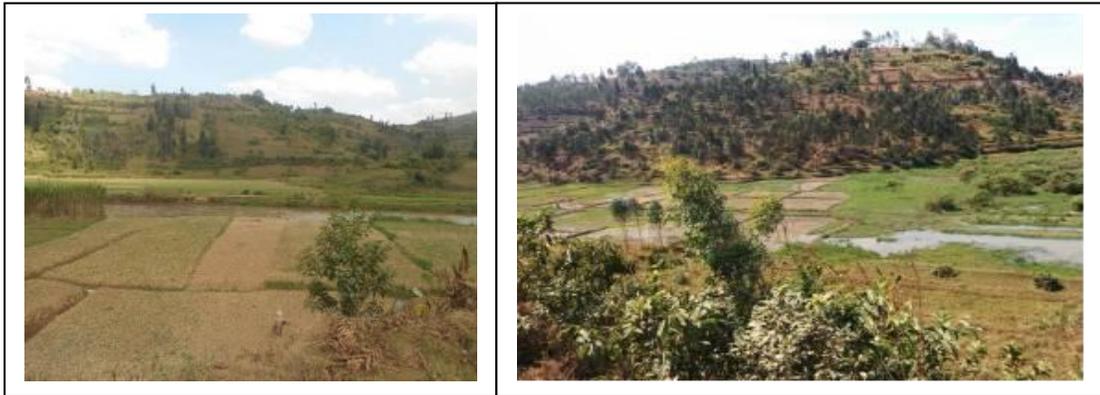
Figure 6: Poor agricultural activities in the Rurangazi wetland

A similar case was also observed as poor agricultural activity in the Rurangazi wetland, where the wetland is slowly being deteriorated illegally. A necessity of either protecting the wetland buffer zone or improving the agricultural activities in the wetland was found necessary to be done.

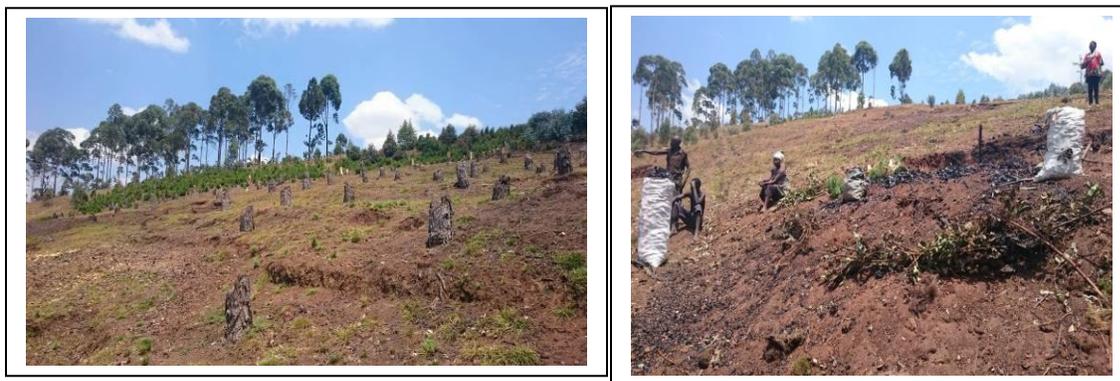
Figure 7: Deforested area in Nyamirama cell for biomass energy and wood production

A typical case of intensive illegal deforestation for wood and charcoal production in Nyamirama Cell, Muhanga sector in the Muhanga district was observed. This is illustrated on figure 9.

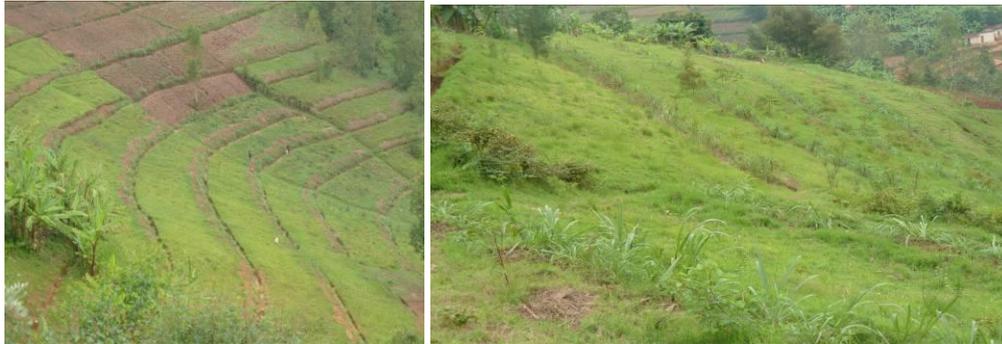
Progressive Terraces: Trenches, *Grevillea robusta*, *Calliandra callotrysus*, French Cameroon and Fruits (Avocado grafted, Mangoes and Papaya)

- Planting of French Cameroon on the visited area is around 99 %
- Digging of trenches done on the visited area is 100 %.
- Planting fruits trees, Agro-forestry and shrubs are done on 99%. (1 % Remaining is related on the beating up of the same seedlings damaged in agro forestry and Fruits)

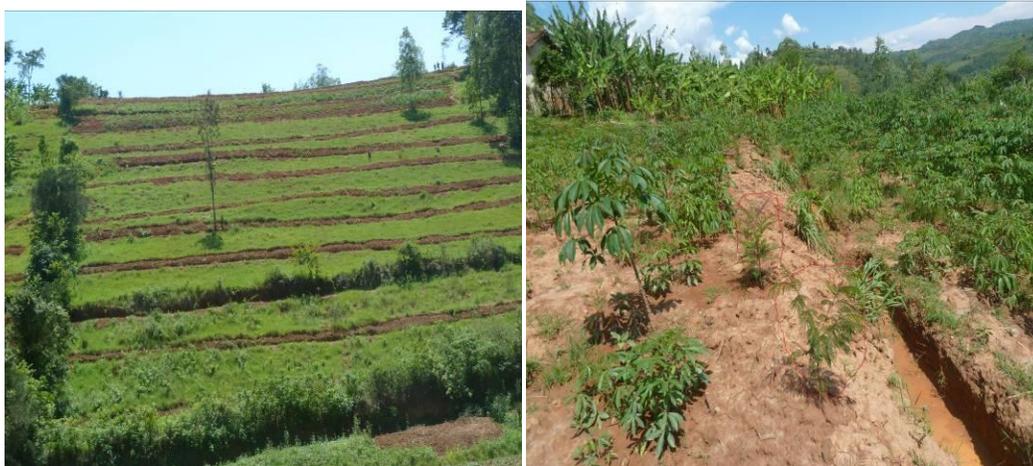
Second example in Karongi District /Murambi Sector, Shyembe cell, village: -Nyamagana and Kavumu, Nyarunyinya Cell, Nyarusave village

- Planting of French Cameroon on the visited area is 94 %
- Digging of trenches on the visited area is 100 %.
- Fruits trees like Avocadoes and Papaya, Agro-forestry like *Greveria robusta* and sample of *Alnus acuminata*, shrubs like *Calliandra callotrysus*, are planted on the rate of 94 % .
