IWRM Programme Rwanda

TR26 – Volcanoes area flood management
January 2017

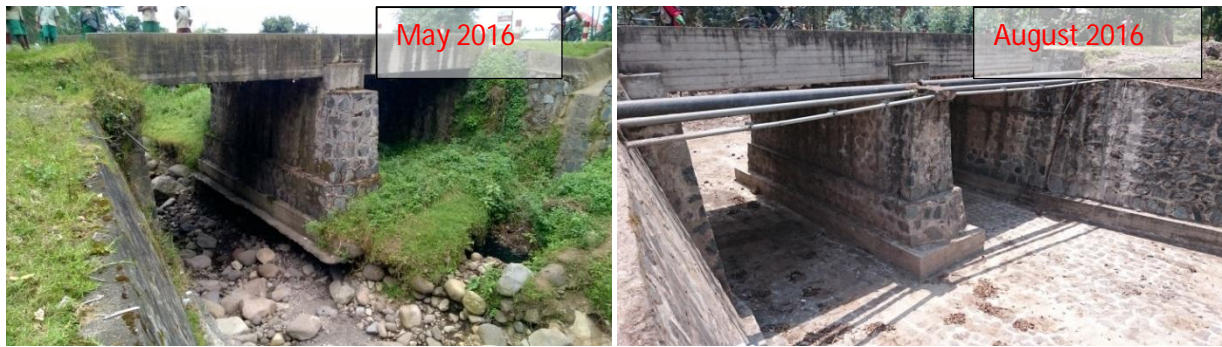
Figure 2 Example of efficient maintenance works on river Rwebeya (Bridge on RN2 road from Musanze to Kinigi)

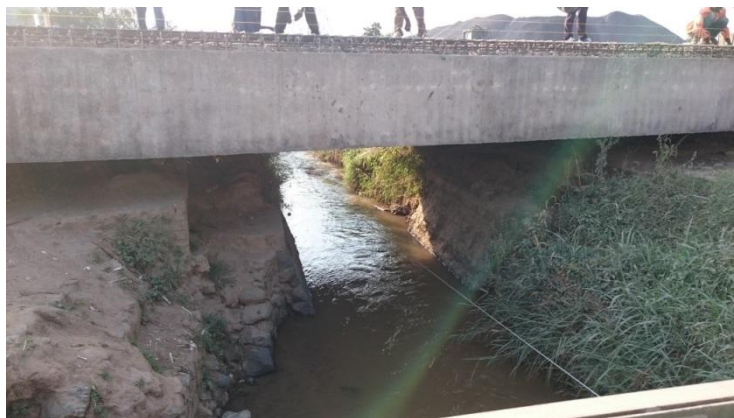
Figure 3 New bridge on river Pfunda: former bridge has not been destroyed, potentially hampering peak flows

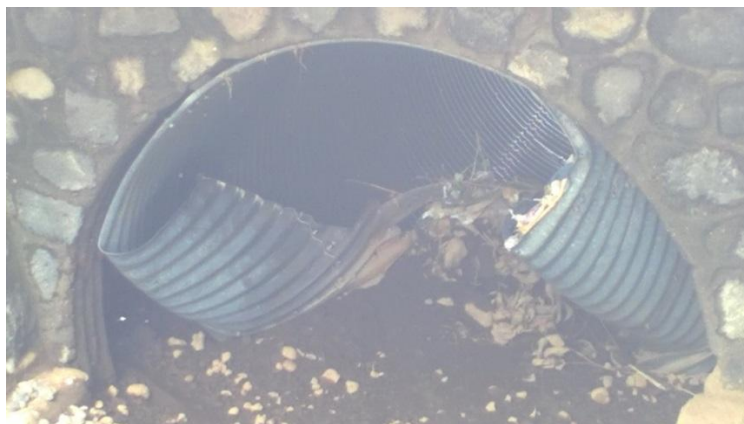
Figure 4 Muhe river bridge (view from upstream): corrugated metal pipe severely damaged (repaired in meantime)

Intervention / responsible agencies	RNRA	MIDIMAR	District of Musanze	District of Rubavu	District of Nyabihu	MININFRA / RTDA
Bridge on river Muhe (RN2 road): erosion around the corrugated metal pipe severely threatens the bank supporting the road. Earlier recommendations to RTDA for repair have not been implemented. Concrete injections need be made urgently (preferably before 20 th of September 2016) to stop the phenomenon. The twisted part of the pipe (at the entrance) is to be replaced or fixed. The pit between the weir and pipe entrance is to be filled with concrete (scoured ground at this place has led to the pipe damaging).						done
New bridge on river Pfunda: population is worried about the flood that maybe caused by Pfunda river due to the new road under construction that might form a barrier for the water in the valley. The RNRA and international experts confirm the risk. Worries exist that the free space under the bridge crossing the river will not be large enough. A check on hydraulic studies made seems needed.				X		X

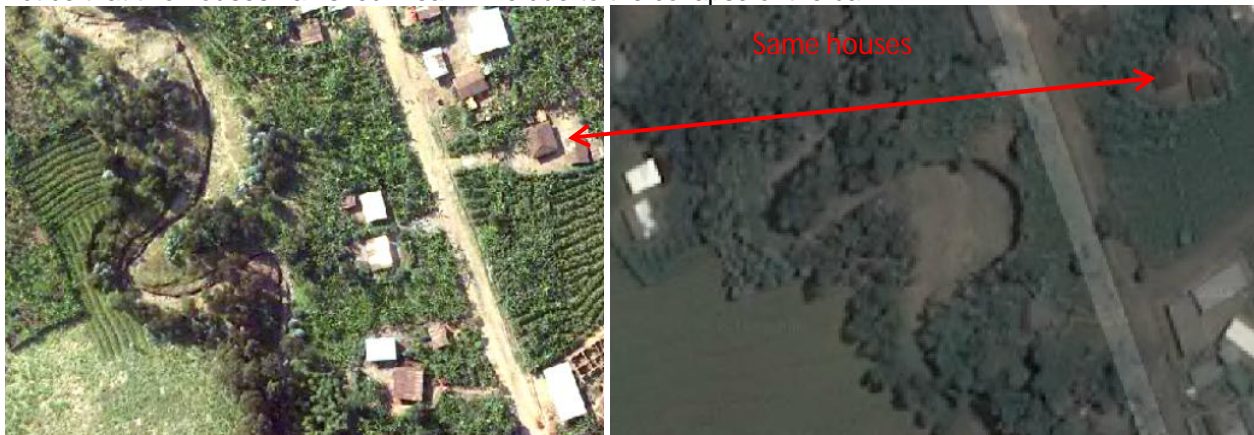
The maps below show an aerial view of the river at two different times: 2008 (left) and 2014 (right): we can notice that two houses vanished meanwhile due to the collapse of the bank.

Figure 21: Comparison of two aerial views (2008 and 2014)

Upstream of Musanze, the main issue is erosion: the important depth of the river bed generates high slopes embankments which are unstable when a flood occurs. Many houses are threatened; some of them have been destroyed.

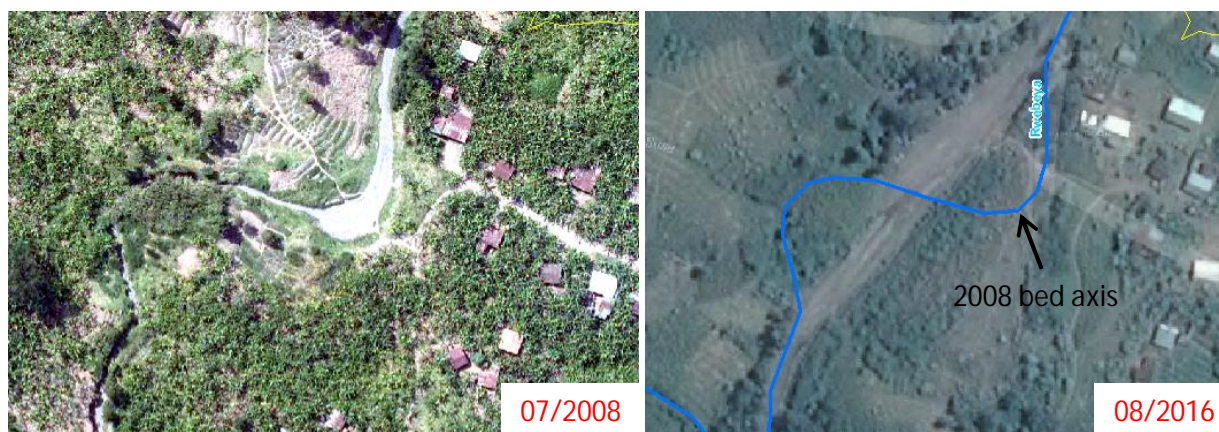
Sediments from the downstream deposition area (Km 9.5) have been extracted in 2011 for aggregates. This area is shown in its 2008 and 2016 states on the aerial views below.

Figure 23: Comparison of 2008 and 2016 states on Rwebeya's downstream deposition area

The change in bed's axis (especially length shortening) leads to a lowering of the upstream bed.

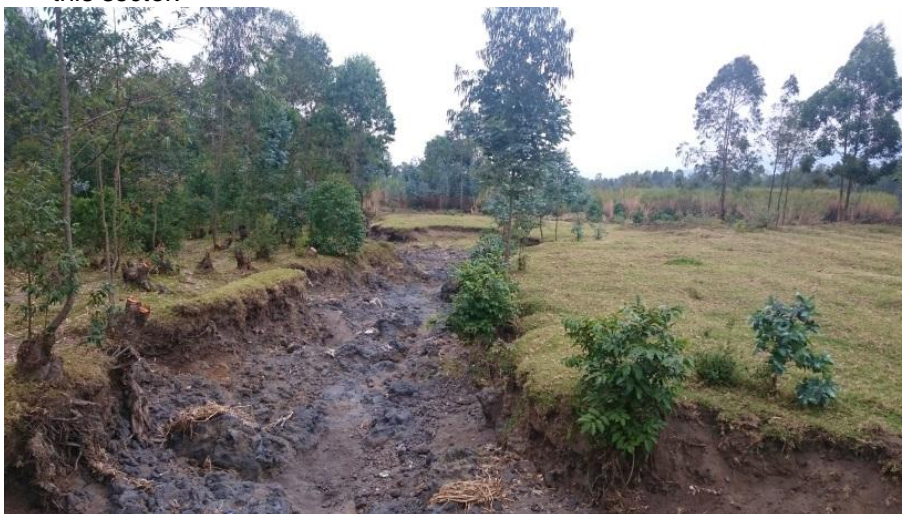
Figure 29: Muhe river: lack of deepness due to close hard basalt layer

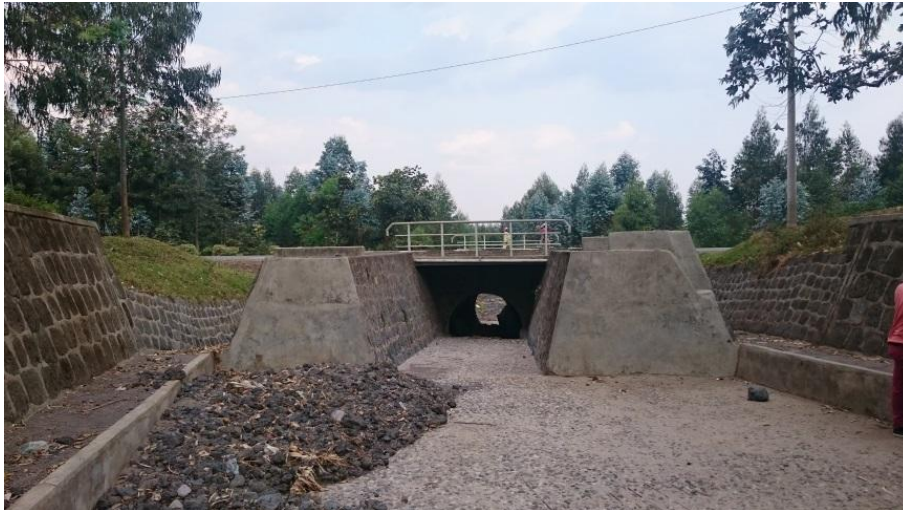
- ∅ Most of them induce limited damages because the water spreads locally and immediately returns to the channel.
- ∅ The bridge crossing the main Road to Gisenyi (Km 8.300) is inducing overflows on the left bank: the water then spreads along the road and floods an entire neighbourhood. Moreover, the main culvert (corrugated metal pipe) is severely damaged and is currently being eroded externally. The bank supporting the road is threatened.
- ∅ NOTA BENE: Since our field visit, the corrugated pipe has been repaired.

Figure 32: Muhe river: brige under the road to Gisenyi (view from upstream)

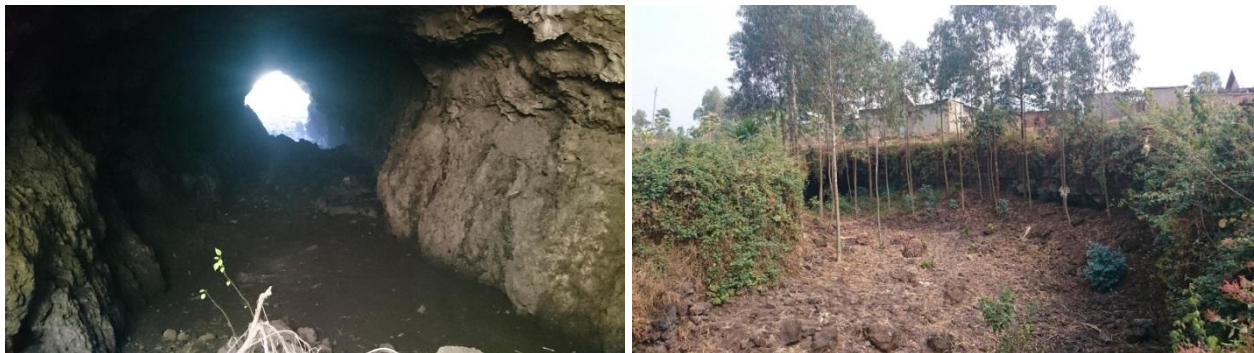
No evidence of link between rivers and caves has been witnessed in this place, but they may play an important role in infiltrating overflows elsewhere (e.g. Mutobo/Mudakama river).

Figure 33: Cave between Susa and Muhe rivers (partially collapsed on the right picture)

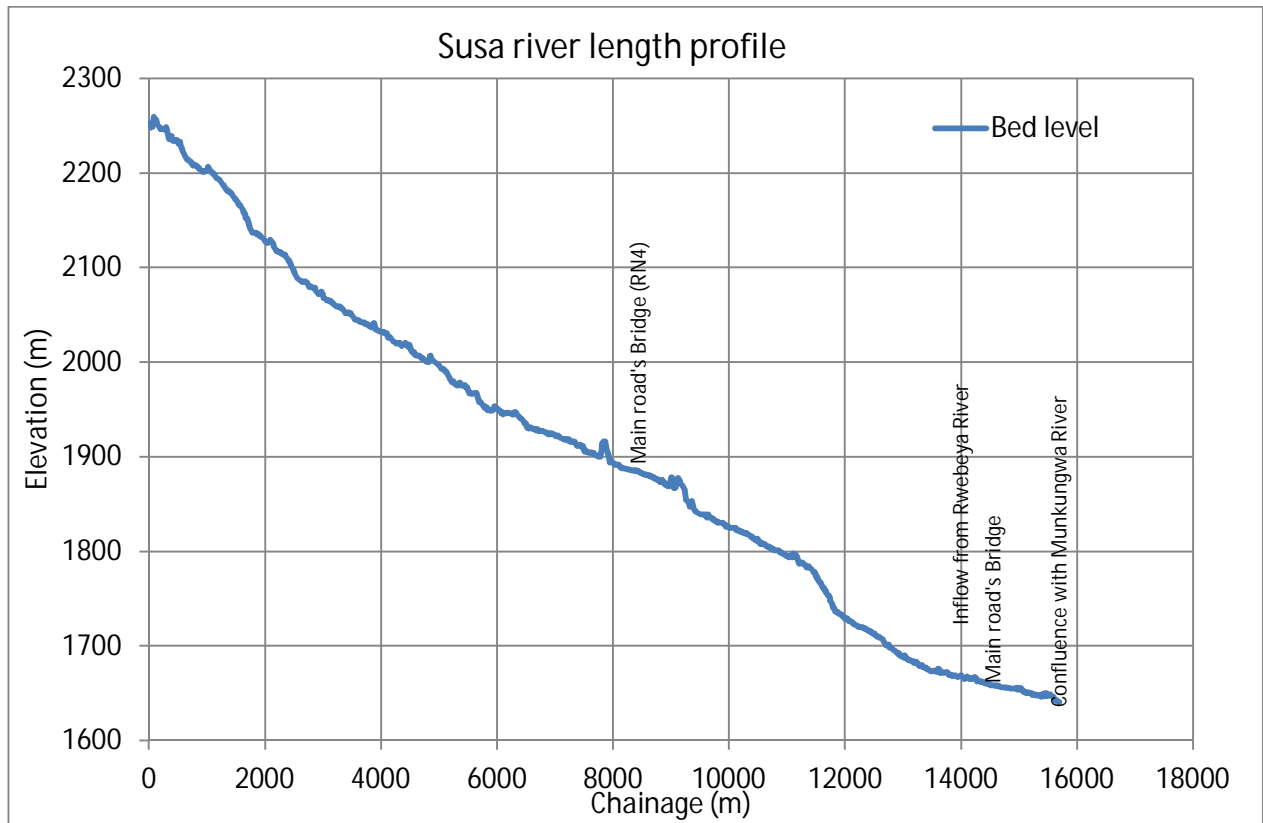
The slope of the river varies from 3% in Muko sector (confluence with Rwebeya) to 5% and more in Musanze’s urban area. Between Km 11.5 and Km12 slope rises up to 15%.

Figure 34: Susa longitudinal profile

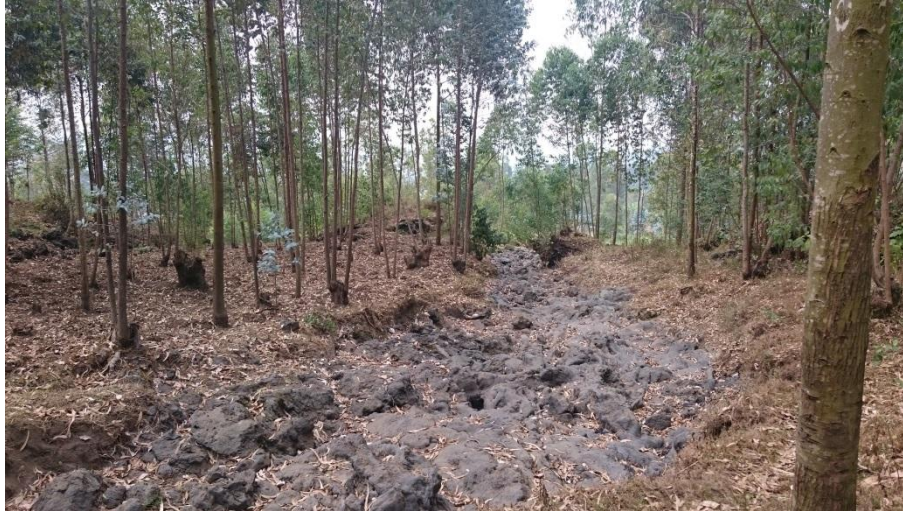
Overflows occur almost everywhere on River Susa due to the lack of capacity of the channel. Indeed, the presence of hard basalt layer under 70 cm of erodible topsoil prevents the river from naturally digging a channel.

Figure 36: River Susa: rocky part is the main channel: no deepness here!

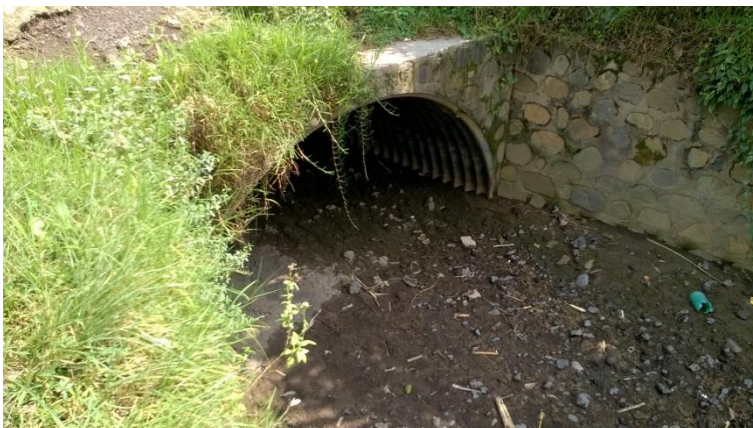
Sediment deposition is an important issue on the river, especially in the downstream part (Muko neighbourhood). Most of the sediments are brought by rivers Rwebeya and Muhe. The bed level rises after each important flood and river and bridges capacities are reduced. Afterwards, a dredging is necessary.

Figure 39: Partially blocked culvert on river Susa (main road to military academy)

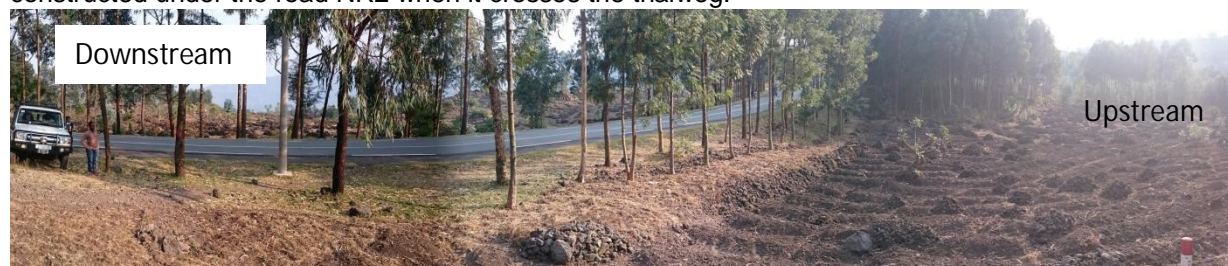
No evidence of flow has been recorded in the downstream thalweg. No hydraulic structure has even been constructed under the road NR2 when it crosses the thalweg.

Figure 40: Panoramic view of the thalweg nearby road NR2

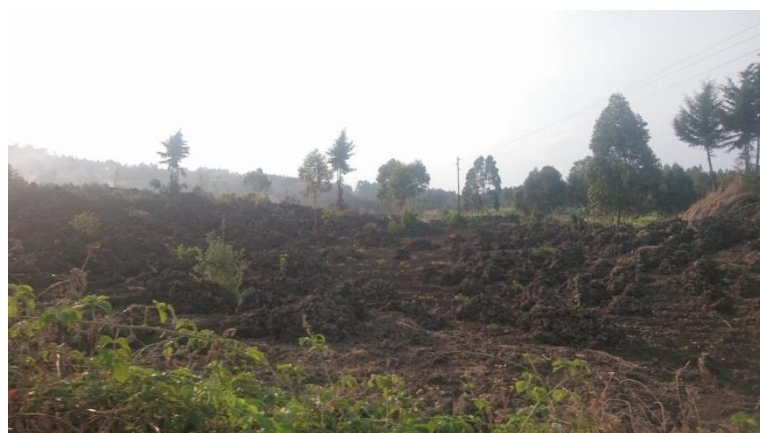
Downstream of the road, the thalweg no more exists.

Figure 41: Downstream of the road

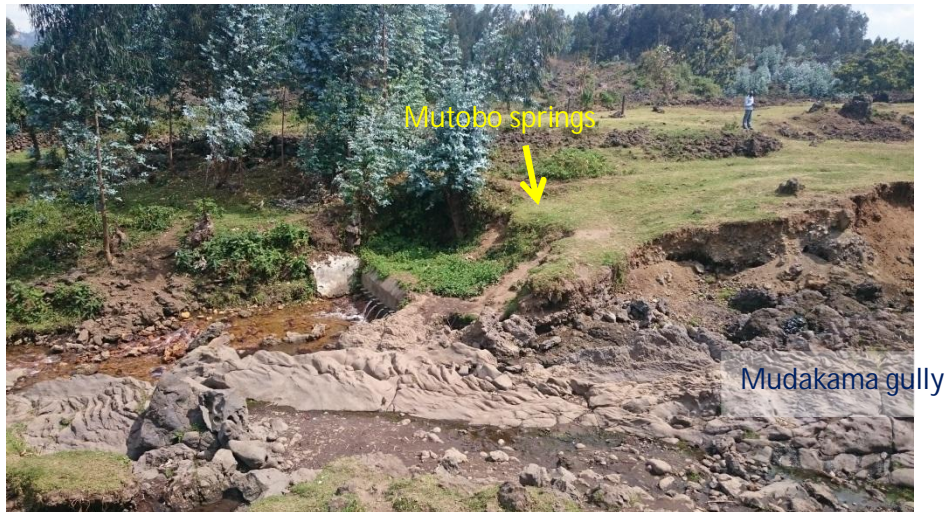
- Ø Mutobo: permanent stream coming from a spring, 2 km upstream of the main road NR2. It does not participate significantly to the floods;
- Ø Mudakama: Gully coming from the volcano slopes and providing almost all the discharge while a flood (mixing then with Mutobo).

Figure 42: Mutobo springs

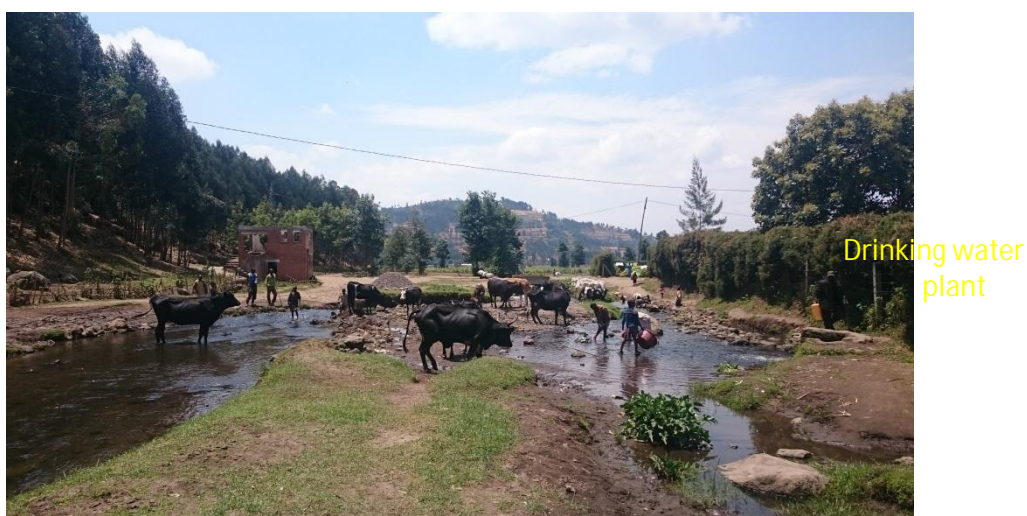
Figure 45: River Mutobo next to drinking water plant (looking downstream)

- Ø After splitting, river Mutobo regularly spills into the fields nearby the bed. The left side reach cross an inhabited area and overflows occur in the village. A school is threatened despite the presence of a dike. Globally the lack of capacity of the channel enables overflows almost everywhere. The road on the left bank also conveys spilled water. Both of the reaches end in caves.

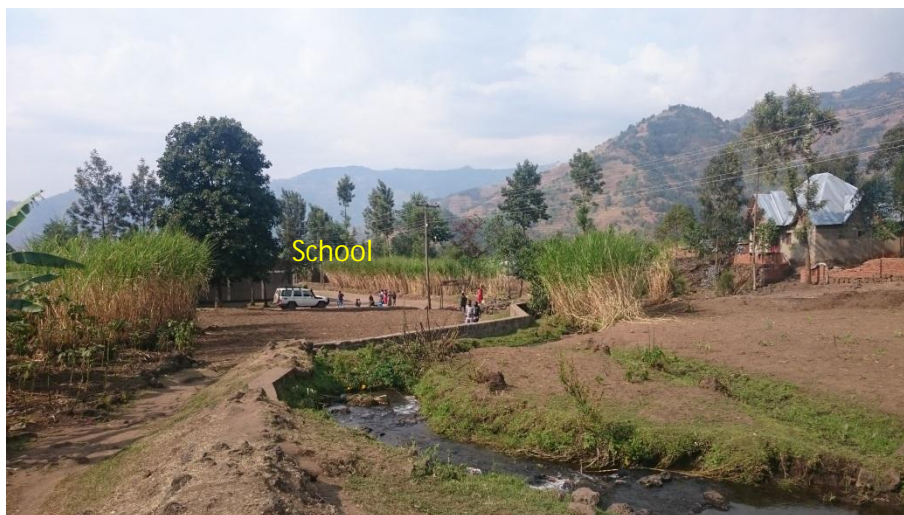
Figure 47: Mutobo left reach: dike overflowed in 2014

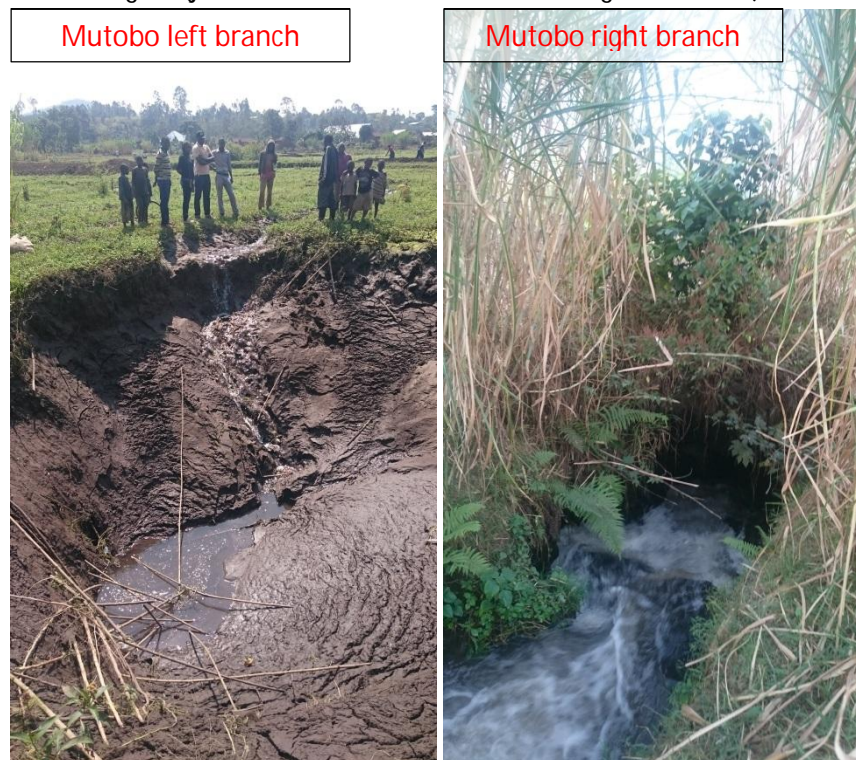
- ∅ The right branch (when looking downstream) enters a large cave. The capacity of the cave seems to be important and could be explained by the permanent flow entering it and keeping carving the tunnel.
- ∅ The left branch is longer than the previous one and also carries less water. It ends into a wet lowland where two caves absorb water. Their capacities are very limited: local residents told that it takes months for the lowland to empty after raining season and that even during dry season the level can rise again (just because of the variation of irrigation needs).

Figure 48: Outlet caves of river Mutobo

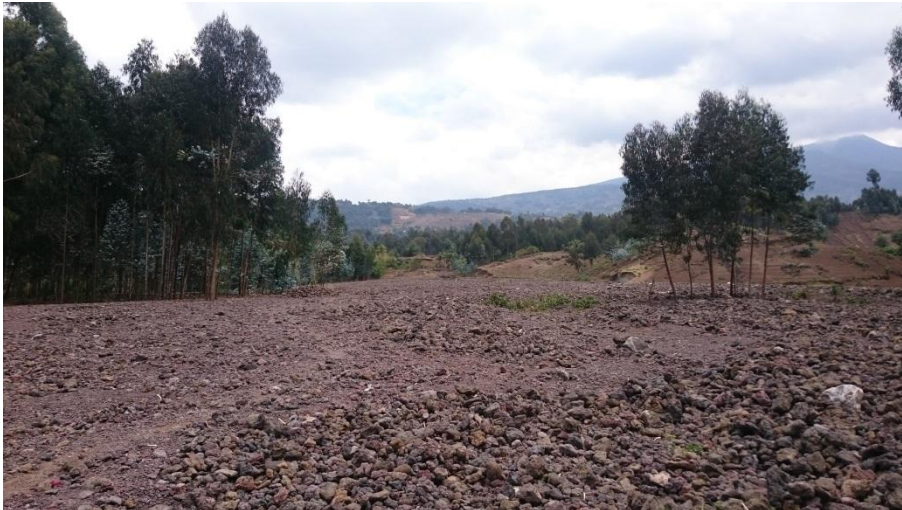
- Ø Rivers Murufurwe and Mungu: both of these have a similar morphology (i.e. gullies crossing fields with soft topsoil) and erosion of the banks is recurrent.
- Ø River Nyabitondore: downstream of the river, a very steep part has severely been eroded. According to witnesses, the river used to end into caves located on a plateau above. The caves have been blocked for some years and people diverted the river to a thalweg in order to avoid overflows: this action concentrated the water and an important erosion phenomenon is occurring. Large amount of stones are transported to the fields downstream: this erosion has no reason to stop as long as the river bed do not reach equilibrium.

Figure 51: Nyabitondore River (view to upstream)

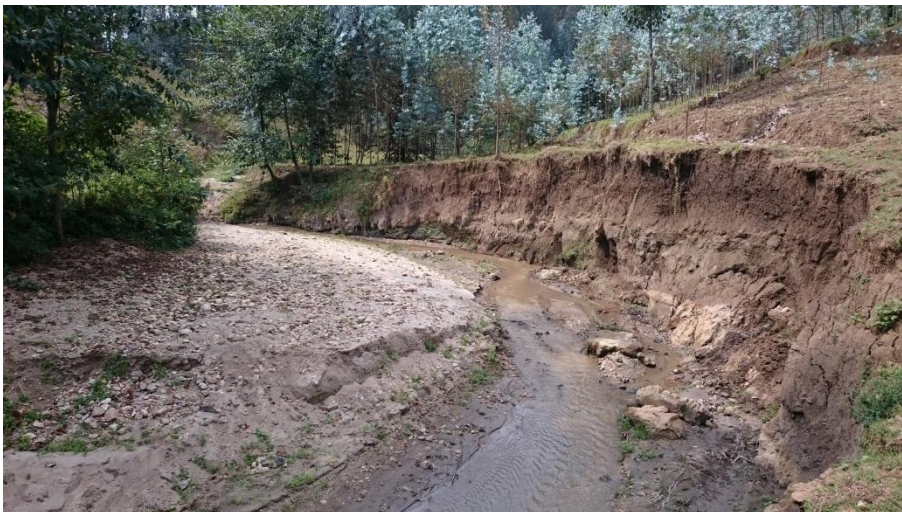
- Ø River Kinoni: in May 2016 occurred the most important flood of these last decades. Consequently, riverbanks have been harshly damaged by the water. Compared to aerial photographs, the river channel seems to have meanwhile expanded.

Figure 52: Erosion on river Kinoni

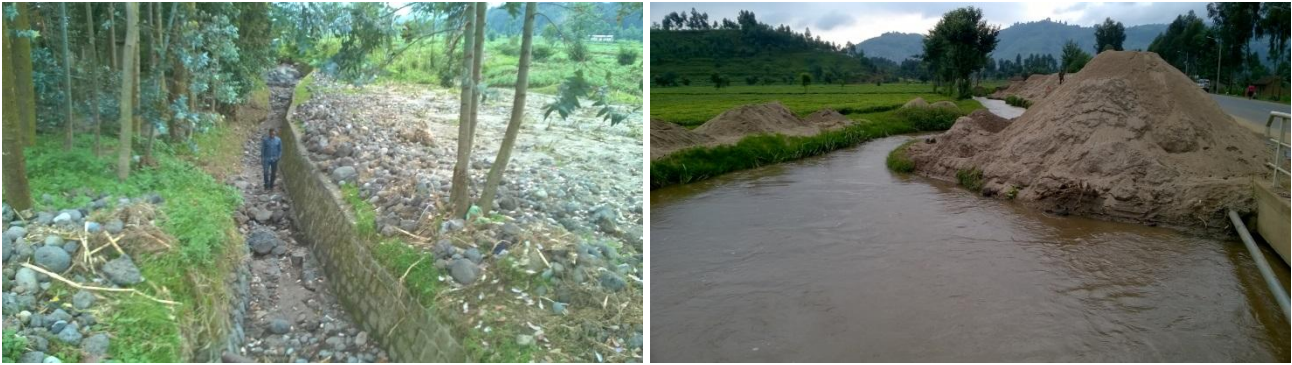
- Ø Bed load: on river Murufurwe, small boulders are carried and spread over the left bank upstream of road NR2 (due to culverts lack of capacity).
- Ø Suspended load: Kinoni River carries a lot of sand that settles when the slope decreases. This happens in the vicinity of the culvert under road NR2. Dredging is regularly performed.

Figure 53: Sediments issues on Murufurwe (left) and Kinoni (right)

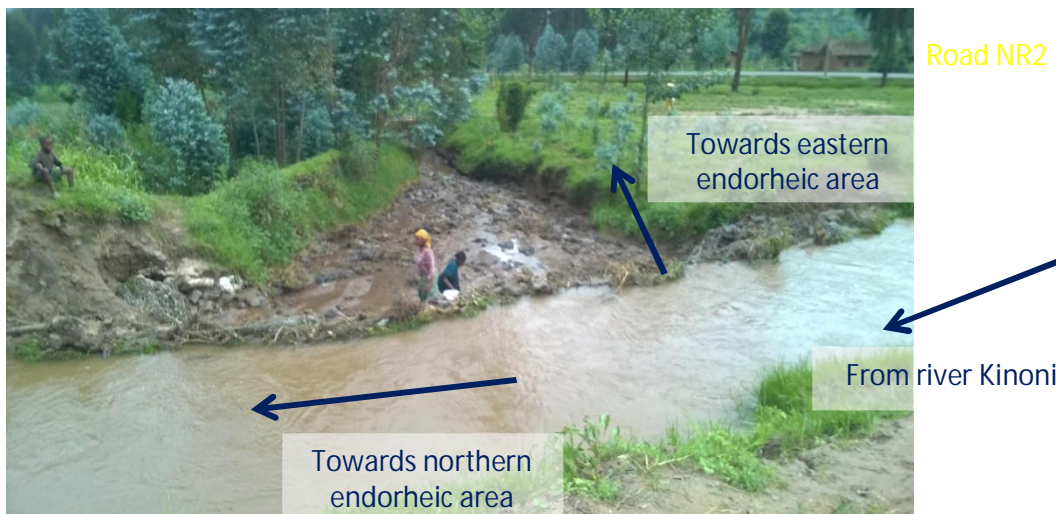
Figure 56: “Diverston point” on river Kinoni (May 2016)

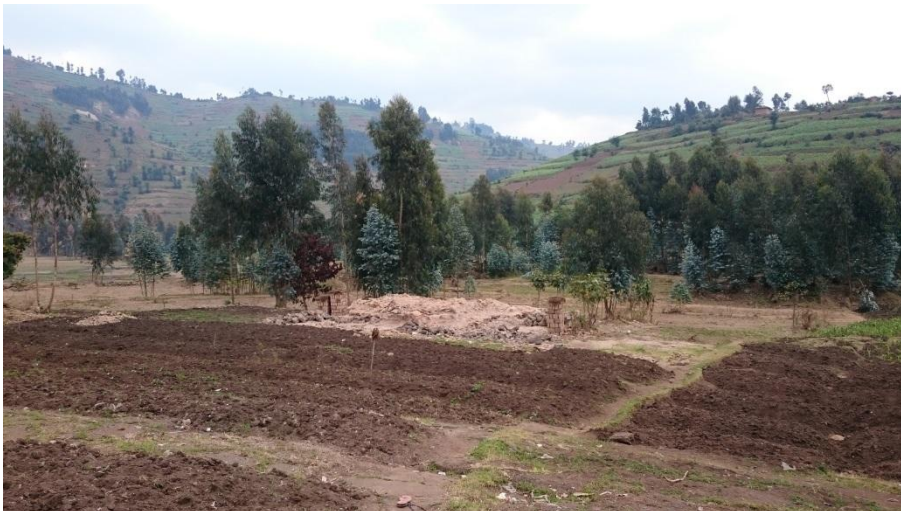
- Ø Bikwi River is a gully ending into an endorheic area north of the road NR2. The 2016 flooding event destroyed a dozen of houses due to long-term inundation of the lowlands (mud-made houses do not support water). If the maximum capacity of the lowland is reached, excess water may flow through a thalweg towards Kinoni River, but this scenario has never happen according to local residents.

Figure 58: Wrecks of a house in the vicinity of the endorheic area - Bikwi River

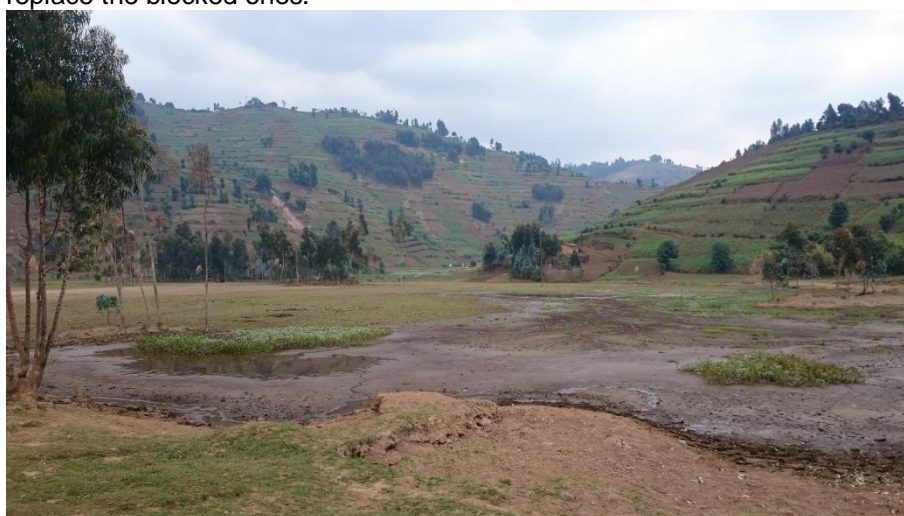
Especially two areas are particularly worrying: Biwki and Murufuwe. On both of them, the existing caves have been blocked reducing *de facto* the capacity of infiltration. As a solution, local residents of Bikwi vicinities are planning to leave the area whereas those of Murufurwe are trying to find other caves to replace the blocked ones.

Figure 59: Bikwi lowland: years after years, sediments settle at the bottom and block the caves

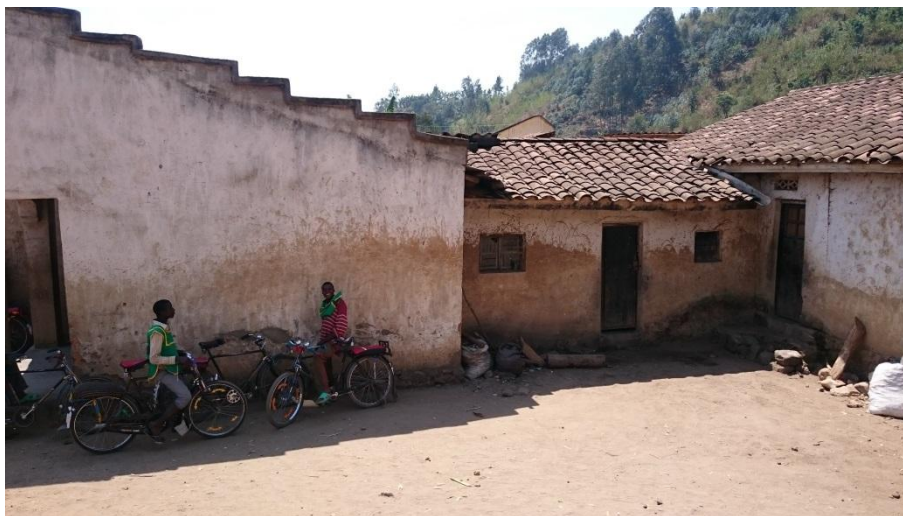
Figure 63: Confluence of Karambo and Gisunyu (right bank): high water mark on 3rd generation houses

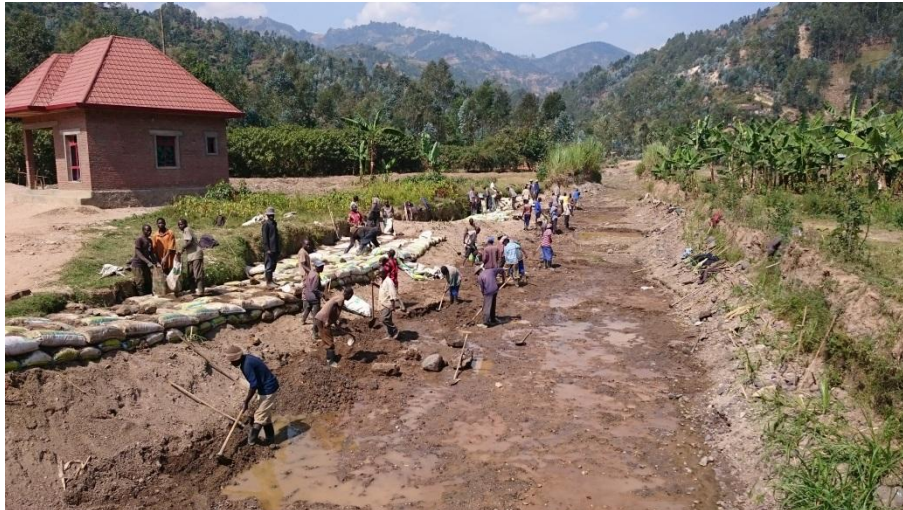
Figure 64: Diversion channel under construction (for excess flow from Karimo and Gisunyu rivers)

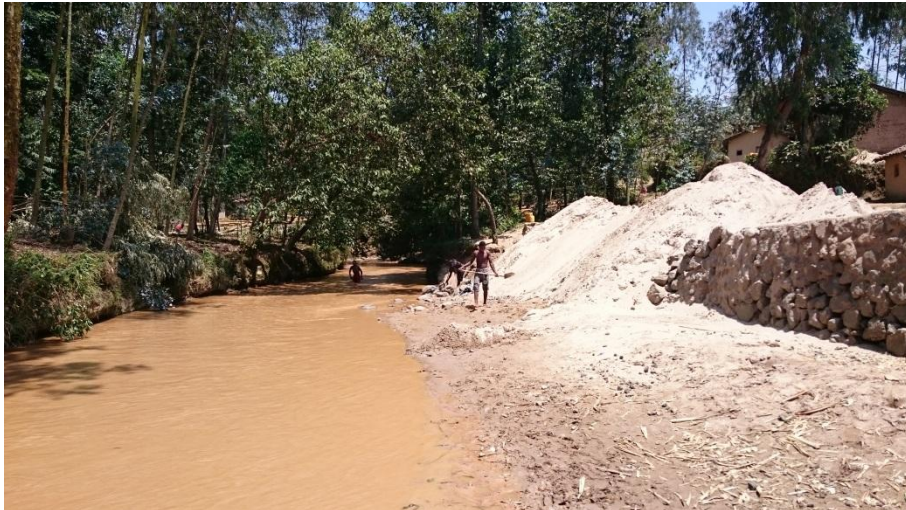
- ∅ The Town centre of Mahoko is severely flooded. It is located at a narrowing part of the Sebeya valley, just upstream of a fall. Overflows occur mainly on the left bank but also on the right bank, nearby the bridge. 2014 has been an important flooding events and some houses were destroyed. Spilled water on the left bank then continues downstream in a look-alike channel that ends downstream of the fall.

Figure 66: Sebeya (looking upstream): water spills over the stone-made wall and floods

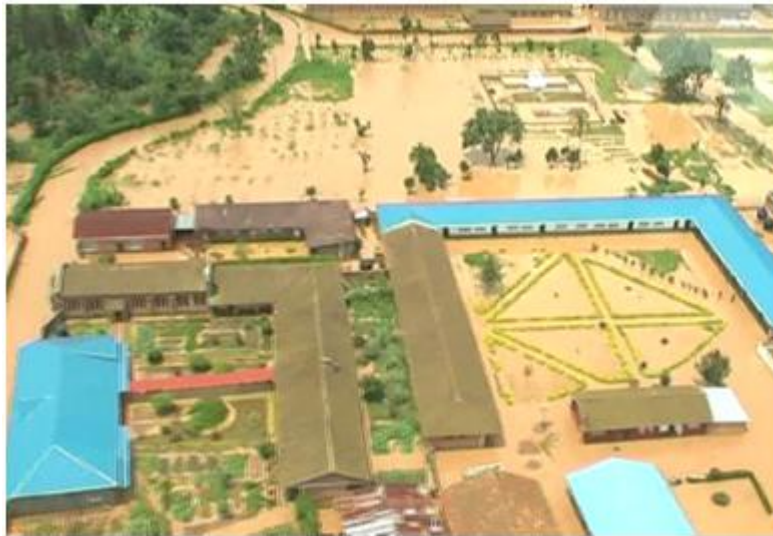
- ∅ The village of Nyundo, located downstream of Mahoko is also heavily flooded, especially the catholic school on left bank called “Petit séminaire”. Pupils and staff have been evacuated with help of the army in 2014. Water could enter through the windows ($h > 1.2\text{m}$). Right after Nyundo a new fall takes place.

Figure 68: Flooding of the school "petit séminaire"² (no date)

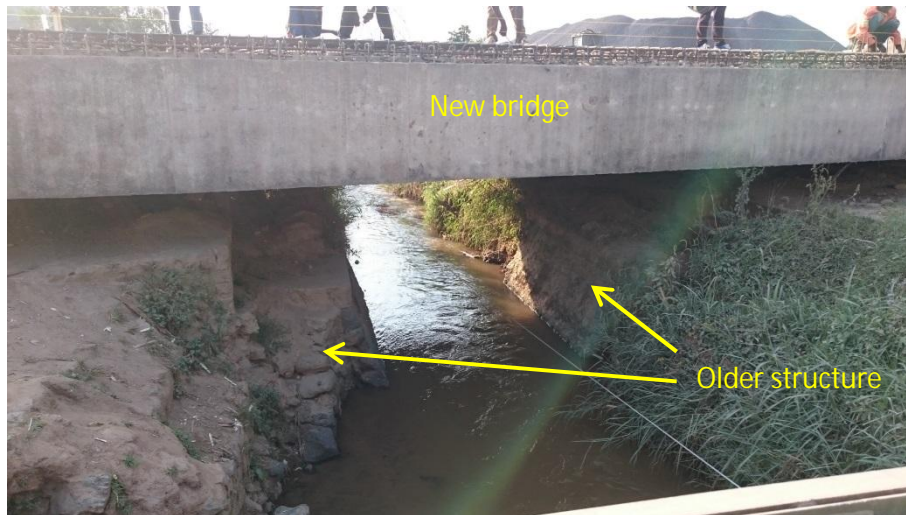
- Ø On river Pfunda (left bank Sebya tributary), large areas are overflowed, especially tea plantations which occupy all the flood plain. We can notice that the new road under construction which crosses river Pfunda has been built on an elevated bank. This structure will probably act like a dam because the entire width of the floodplain already used to be flooded before the new higher road and the enlargement of the bridge may not be enough (moreover, the former bridge has not been removed see picture below).

Figure 70: New bridge on river Pfunda (road to Rutsiro)

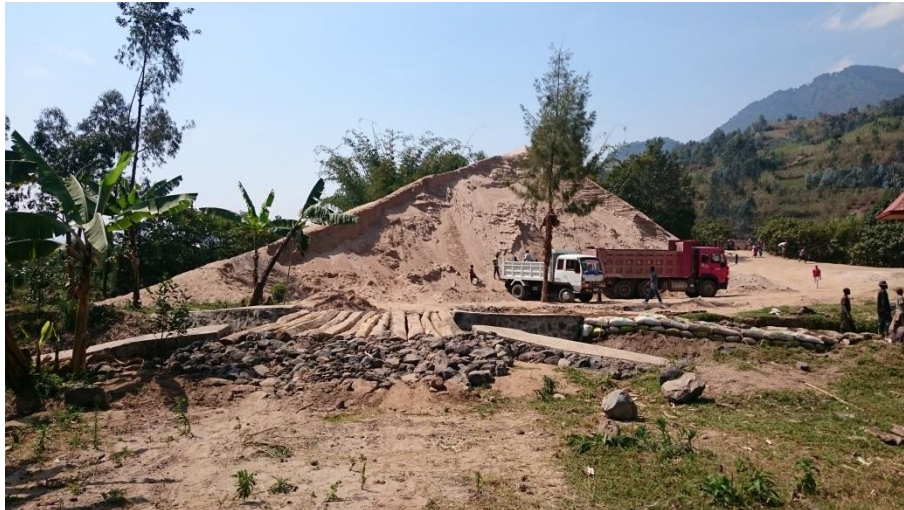
Sediment transport is an important issue on Sebya River and is mainly caused by mining activities in the upper catchment, official as well as clandestine.

Figure 71: Sand mining in Sebeya river

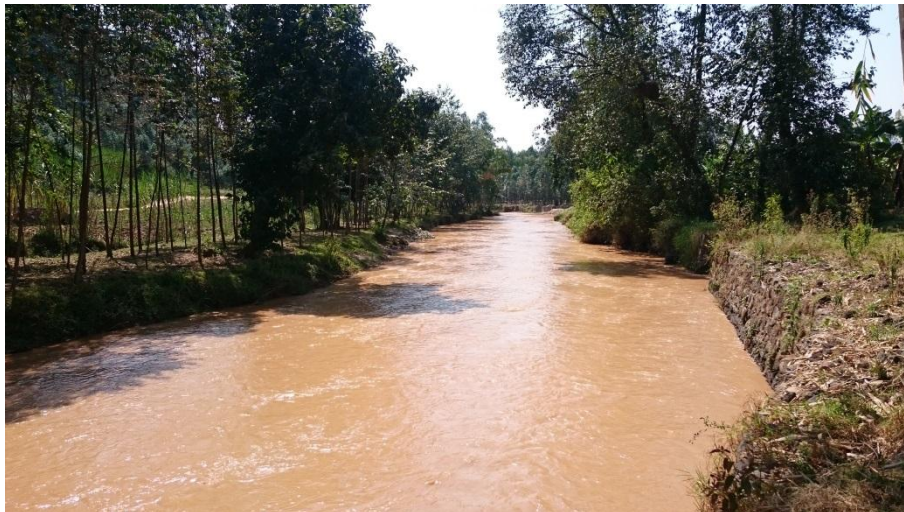
Figure 72: Suspended load in Sebeya river

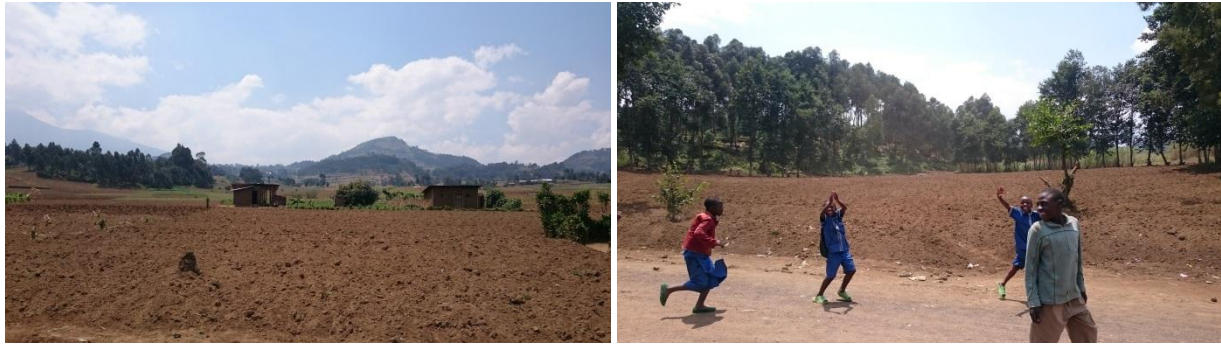
These thalwegs carry water twice a year, during the autumn and spring seasons. The floods dynamic is very particular on this area due to the strong permeability of the soils: when a storm (local rainfalls) strikes somewhere on a catchment area, flood propagates downstream on few kilometres before it disappears due to high seepage.

Figure 74: Thalwegs - Lack of deepness and no channel makes them hard to locate

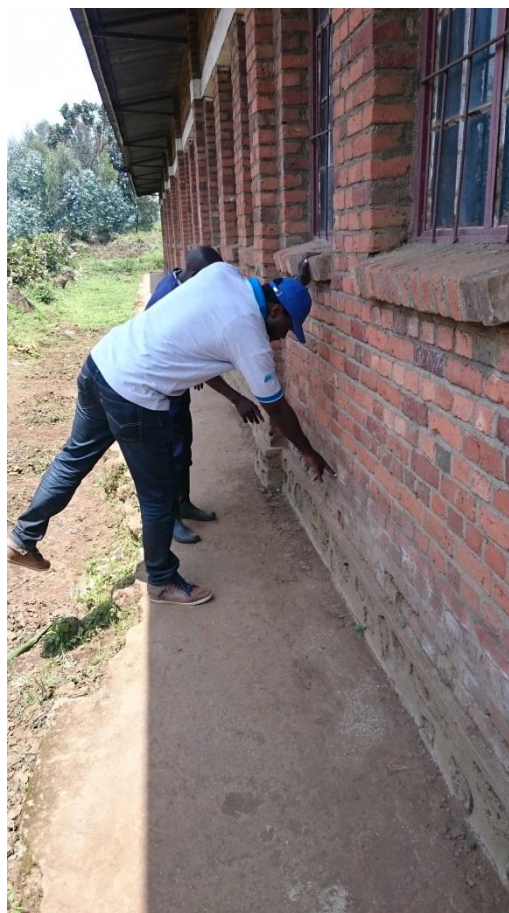
The most important flooded building is school “St Matthieu”, in Busamana sector.

Figure 75: School Saint Matthieu: school's warden indicates high water mark

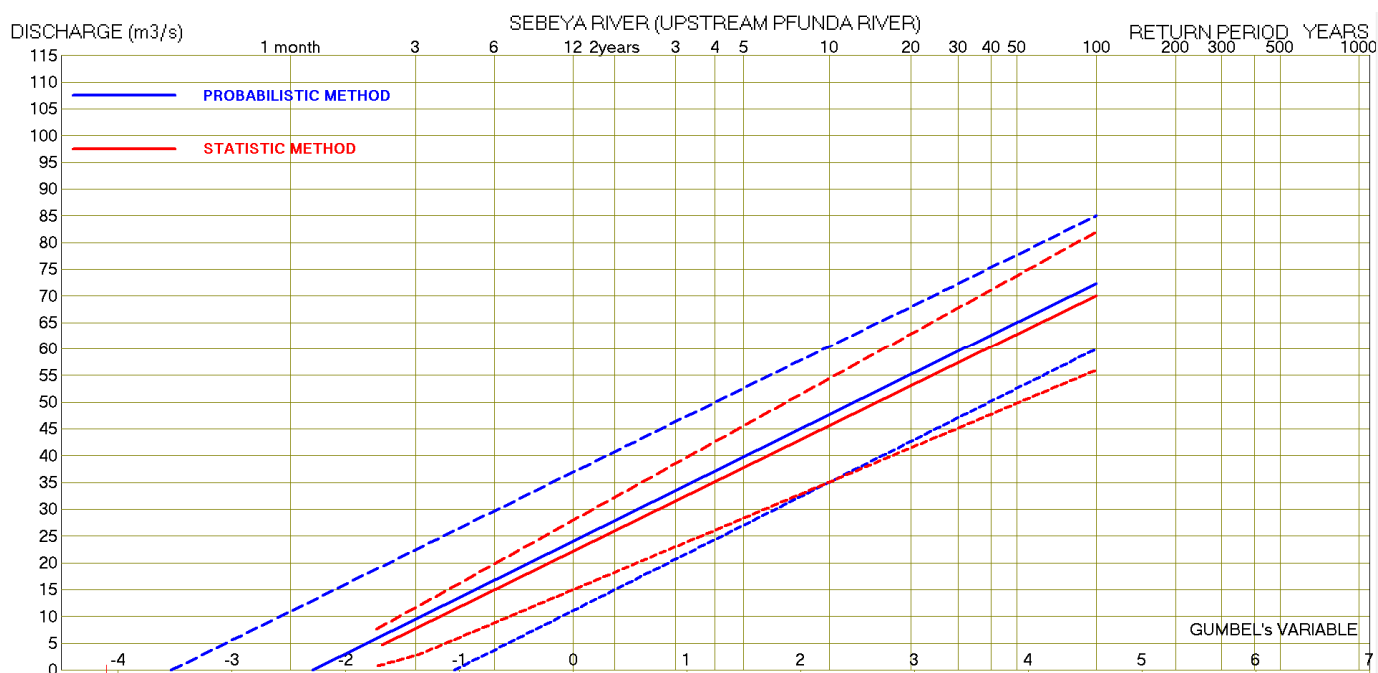
Figure 95 : Statistic and probabilistic discharge on Sebeya River upstream Pfunda

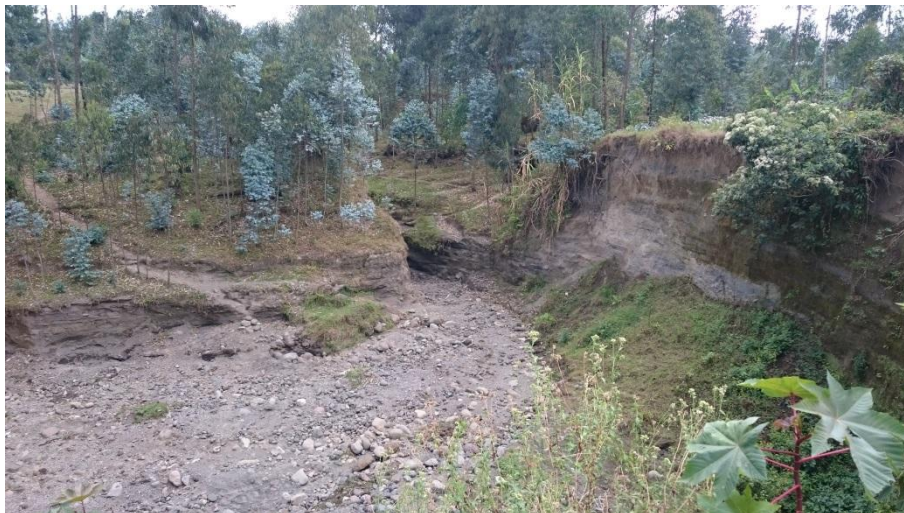
Upstream of Musanze, some protections are locally needed to avoid further lateral erosions (see 2.1.2.1). These protections are to be placed only in the vicinities of threatened areas. No specific design will be provided hereunder: just a typical cross section to be adapted according to the cross section.

Figure 115 Threatened embankments requiring lateral protections

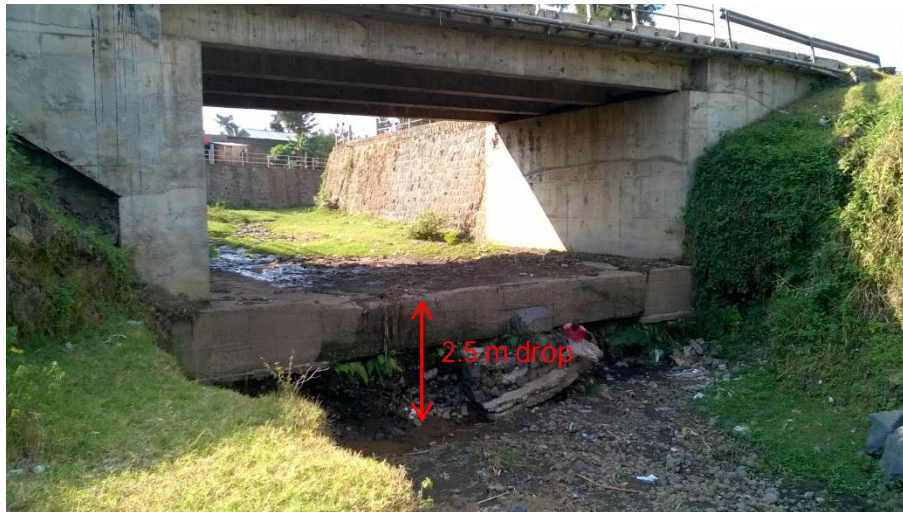
The Bridge of the national road NR2 is damaged downstream where erosion is currently digging under the slab. Repair works have to be done quickly.

Figure 117 Rwebeya bridge in Musanze-city

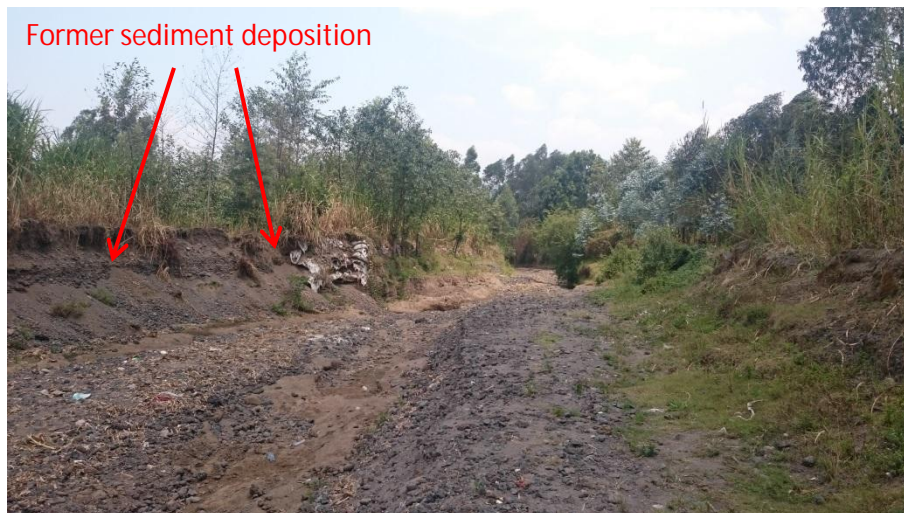
Figure 122 Area to be reworked into a debris basin (downstream view)

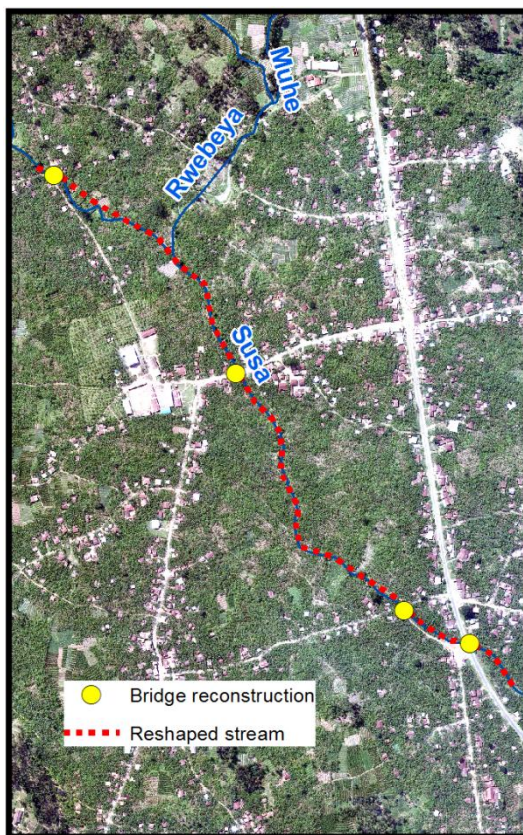
The total length of the river training is 1.3 km. Four hydraulic structures will have to be rebuilt because of their insufficient current capacities.

Figure 127 Proposed river training

In all cases, the river training can't be implemented unless debris basin is made.

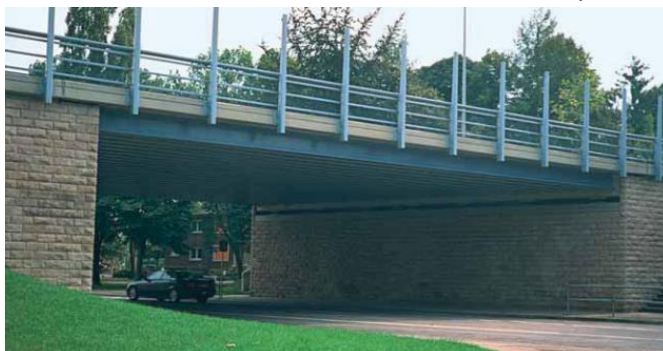
- Ø Composite steel beam Bridge: quite easy to build, it provides enough span to avoid piers in the river bed. The obtained deck is thin compared to other technologies.

Figure 129 Example of a 19m-span composite steel bridge

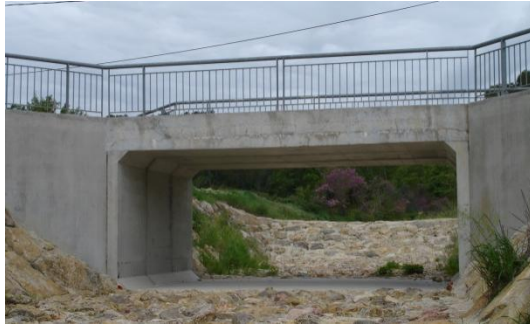
- Ø Culverts: two 5x2.5 m box culverts can be built. This is the economic way to implement hydraulic structures in a river (prefabricated structures).

Figure 130: 5 x 2.5m culvert

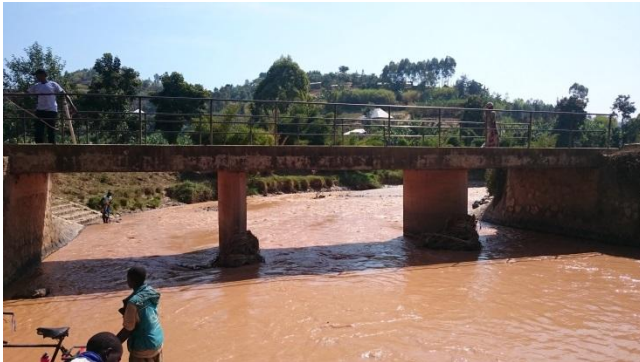
- Ø Concrete Slab Bridge: such structures can be made in Rwanda but will require one or two piers in the river bed.

Figure 131: 15m span slab bridge on Sebeya river

The bridge enabling access to “petit séminaire” will also have to be widened to a 15m span. Such bridges can be easily implemented (see for instance the one in Gihira, Figure 131).

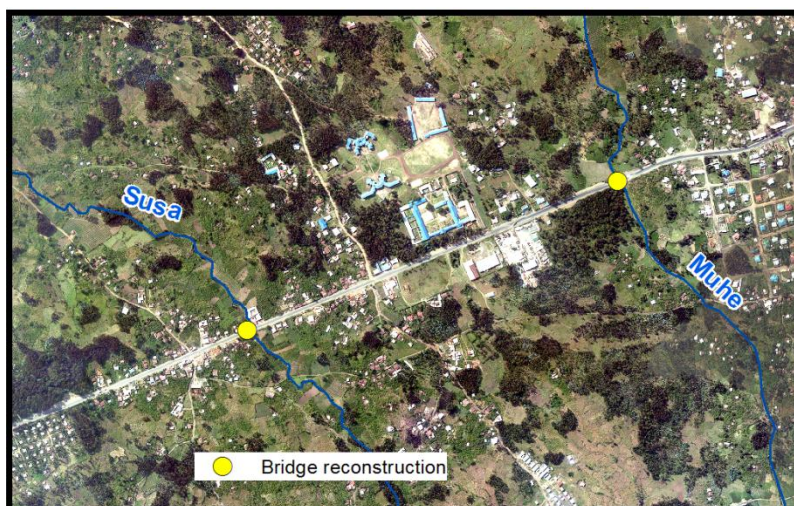
Figure 132 Muhe and Susa's hydraulic structures

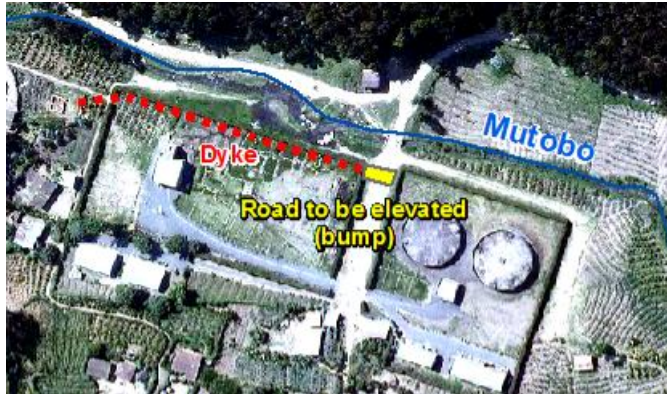
Figure 134 Location of the projected dyke

Wasac plant is threatened by Mutobo River when floods occur. The plant can be protected along small linear thanks to a levee.

This will not only protect the water plant but also the houses located south of it.
