IWRM Programme Rwanda

TR26 – Volcanoes area flood management
January 2017

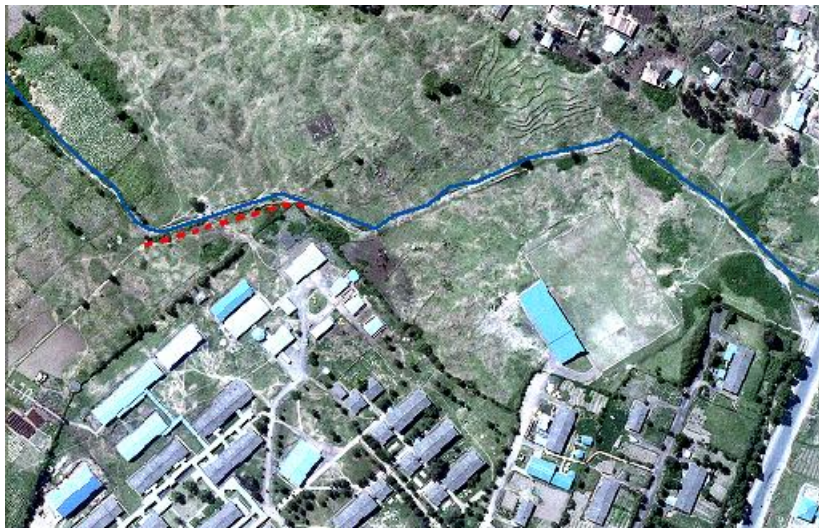
Figure 136 Location of the suggested levee

The campus of the University of Rwanda is located right bank of Rungu river. It is threatened by spilling water, especially upstream of it, in a curve. This curve is not natural and the river has probably been detoured while constructing the campus. Overflows may happen and water could reuse the former river bed through the buildings.

A levee could be built right bank to protect the University from flooding.

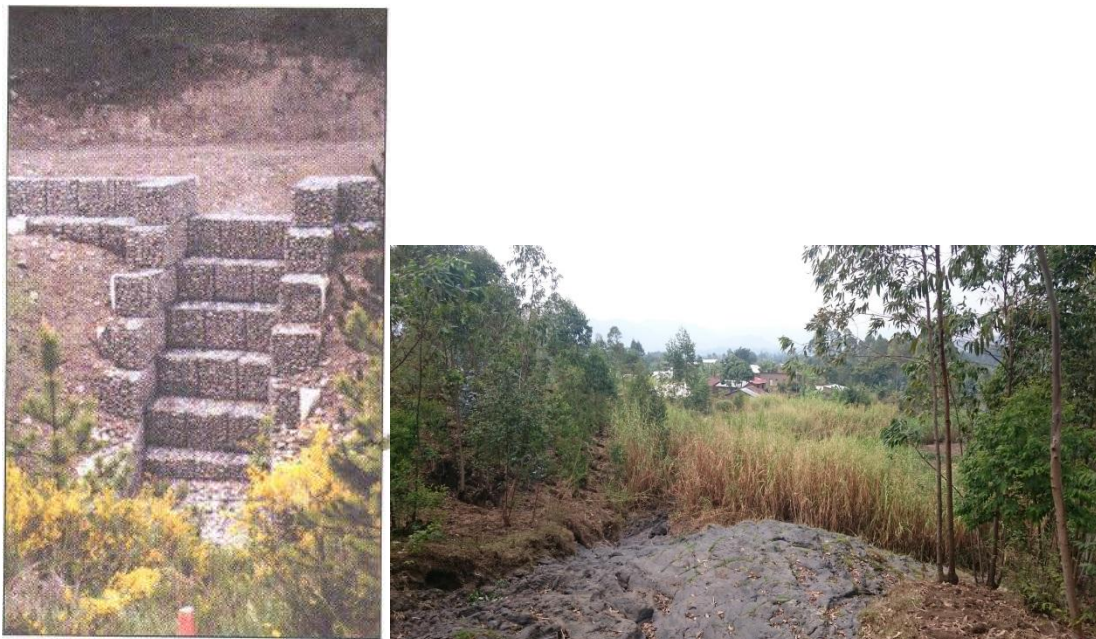
Figure 140: Gabion boxes weir (left) / Natural bedrock fall on Susa River (right)

Two weirs have to be built on the diversion channel because of two important slope breaks. The first drop is 9m high (Km +0.4) and the second one is 20m (Km +0.75).

Before advising particular structure for weirs, a soil investigation has to be performed to estimate how close the bedrock is. Indeed, a simple soil stripping could be implemented in order to use bedrock as natural protection.

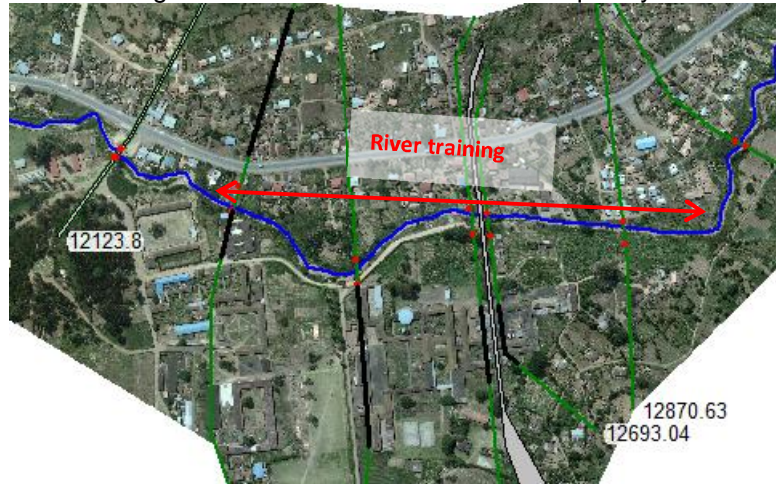
Figure 141 Proposed river training (HEC RAS cross sections in green)

“Petit séminaire” of Nyundo has been severely flooded due overflow from Sebeya river. The river bed is not wide enough.

The proposed solution is to enlarge the river bed to decrease the frequency of overflows.

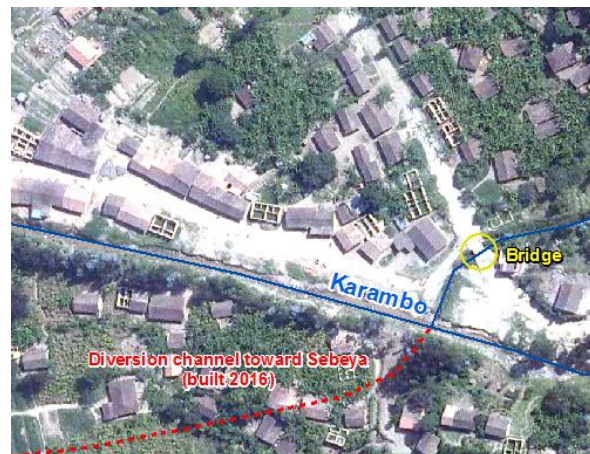
Figure 144 Aerial view of the vicinities of confluence between Ginsunyu and Karambo

At the confluence of Karambo river and Gisunyu Gully, left bank is severely damage by floods (erosion). The bridge crossing Gisunyu has been damaged: right abutment has been scoured and the structure is threatened.

Overflows occur right over bank (see the red arrow in Figure 144), downstream of Gisuyu Bridge. These overflows may not happen anymore because of the newly built diversion channel enabling a large quantity of water from the two streams to reach the Sebeya River via another channel. This diversion channel is almost as large as the Karambo River.

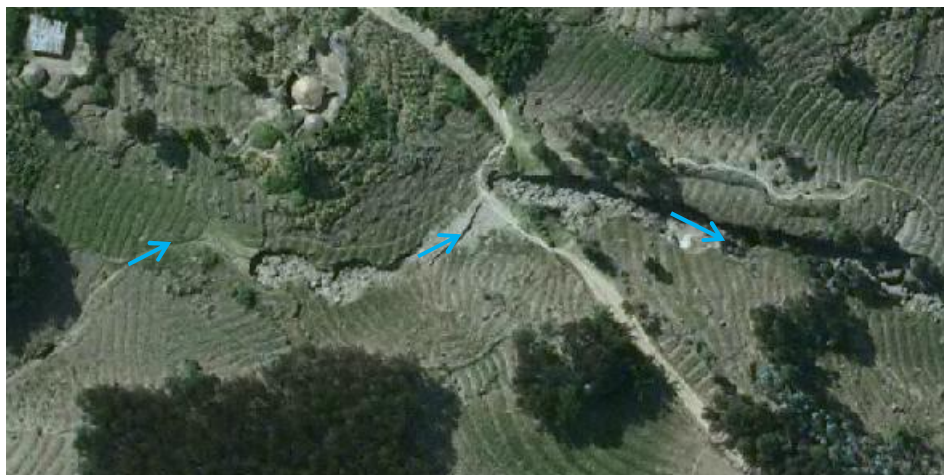
Figure 146: Example of forming gully, Shingiro sector

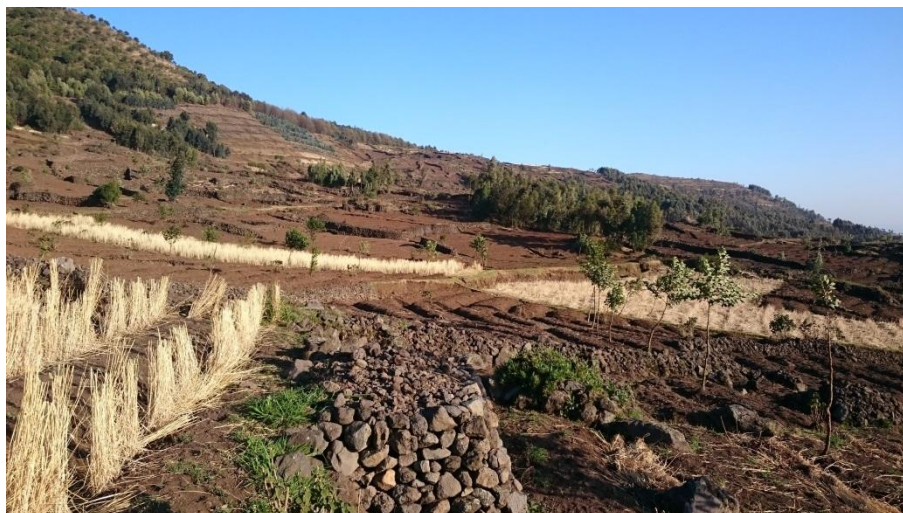
Figure 147: Example of stone-made fences: could be better rearranged to reduce runoff

We have seen an example of what is possible to do, on the slope of Muhabura mountain.

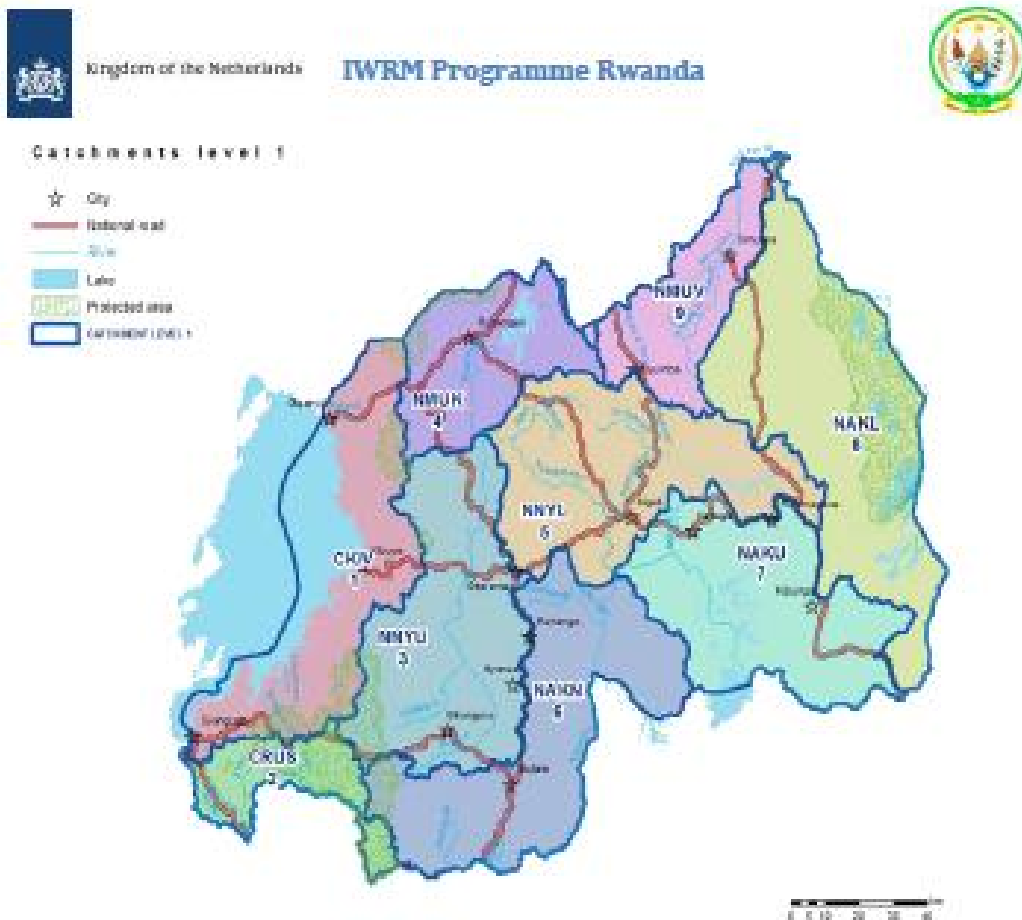
The hydrological system of Rwanda is sub-divided into two major basins (Nile basin covering 67% of the country’s territory and Congo basin covering 33%) and nine level one catchments as illustrated in the following map.

In the above map, the initials:

1. CKIV stands for Congo Kivu Catchment
2. CRUS stands for Congo Rusizi catchment
3. NNYU stands for Nile Nyabarongo upper catchment
4. NMUK stands for Nile Mukungwa catchment
5. NNYL stands for Nile Nyabarongo lower catchment
6. NAKN stands for Nile Akanyaru catchment
7. NAKU stands for Nile Akagera upper catchment
8. NAKL stands for Nile Akagera Lower catchment
9. NMUV stands for Nile Muvumba catchment
