# The State of Soil Erosion Control in Rwanda

May 2022

## 1. Background to National Erosion Control Mapping

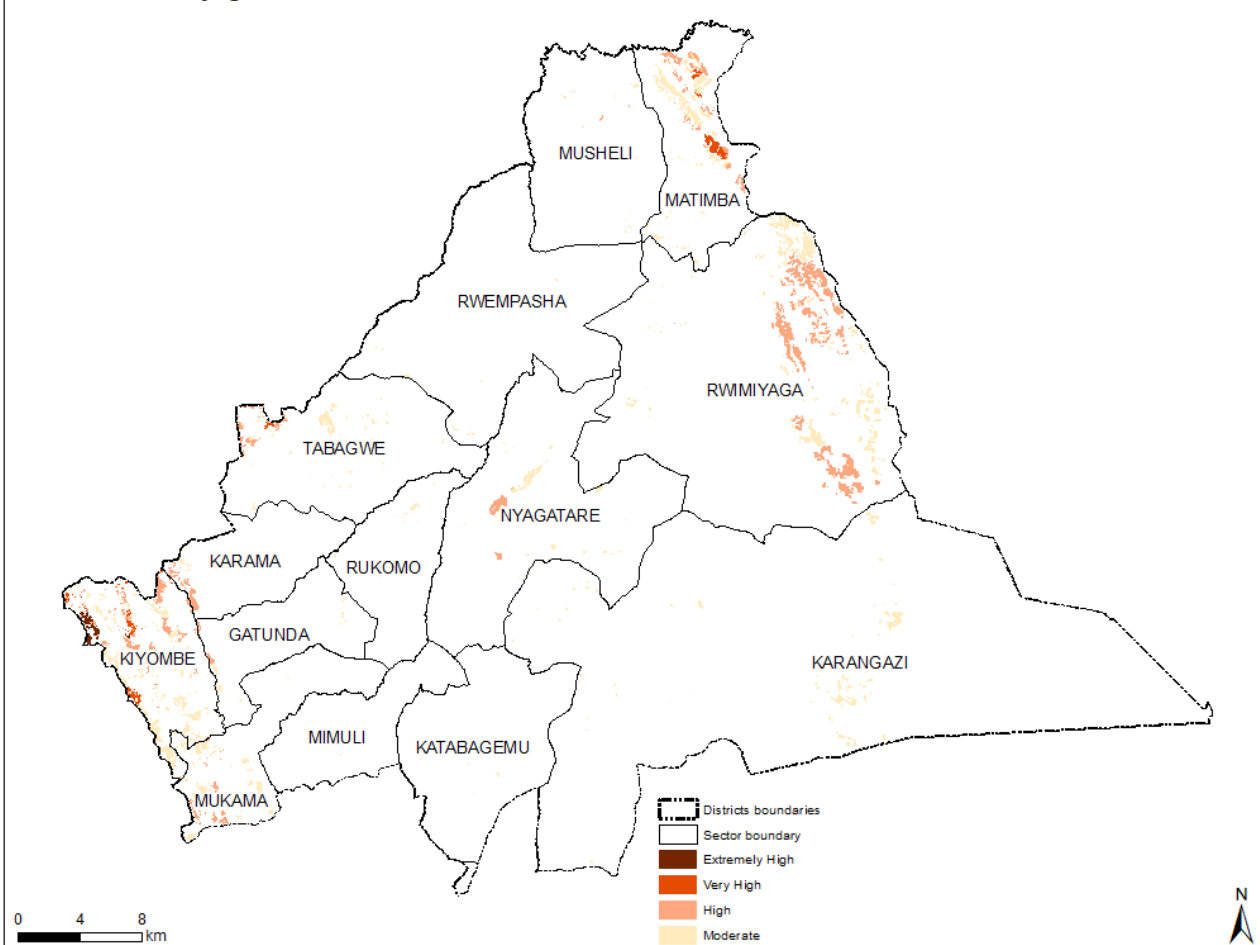
**Figure 135: Erosion risk in Nyagatare District**
